Aircraft Structures Technical Memorandum 503

**EVALUATION OF A DAMAGED F/A-18**  
**HORIZONTAL STABILATOR (U)**

J. PAUL

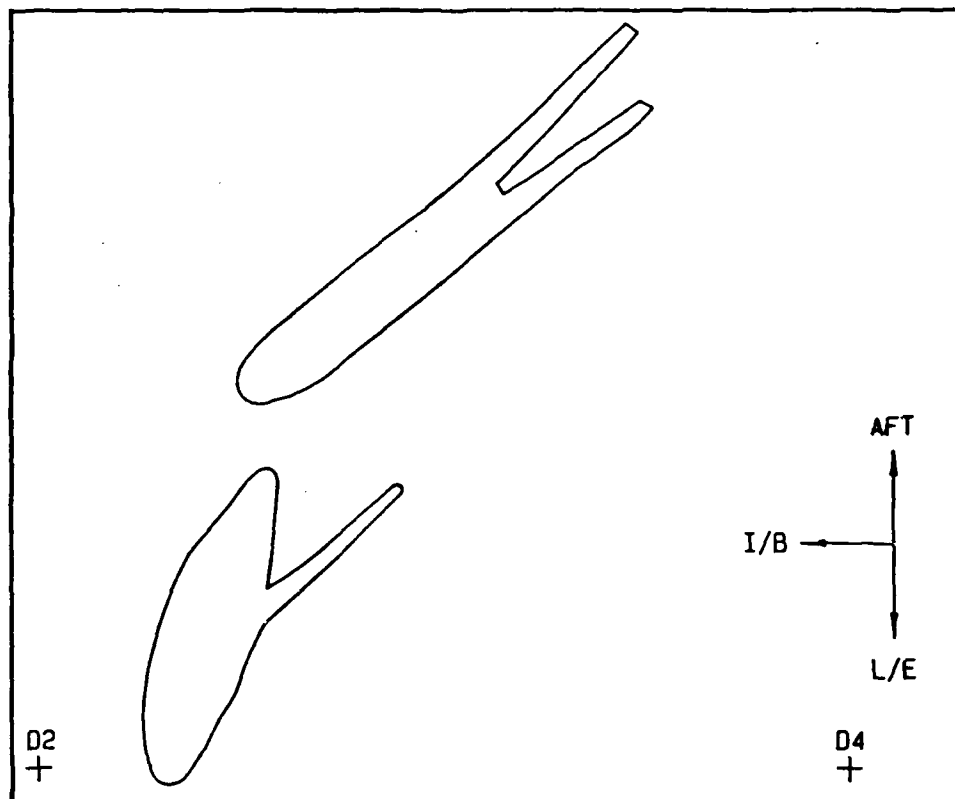
FIGURE 11 SPATE PICTURE OF DAMAGE ZONE

To investigate the stress concentration around the damage further, a number of detailed thermal emission scans were taken. The SPATE photo is orientated as a mirror image of Figure 8. The results of one of these scans is shown in Figures 11, and to assist the reader in interpreting the picture, an overlay is provided Figure 10. Examination of this figure reveals that, as indicated by the strain gauge and compliance measurements, there was no 'classical' stress concentration affect around the damage. There is also a region, in the vicinity of gauge U2, which gave a spurious thermal emission reading. This spurious reading vanished when the structure was excited at 12 Hz.

The strain survey conducted indicates that there is minimal structural degradation resulting from the fragment strikes. The results also show that the damage produces no measurable change in local compliance. The thermal emission results confirm these measurements and do not show the classical stress concentration around the fragment holes. Since the damage does not appear to compromise the compliance of the structure a simple externally bonded repair should suffice. This investigation has revealed that such a repair will not result in a significant change in the local neutral axis or an associated increase in secondary bending.
